Jabiru Landing Incident 19 July 2010 Lancair VH-YFM

Brief History and Recovery Activity Log

Prepared by Fred Moreno 8 August 2010 from notes taken during the recovery

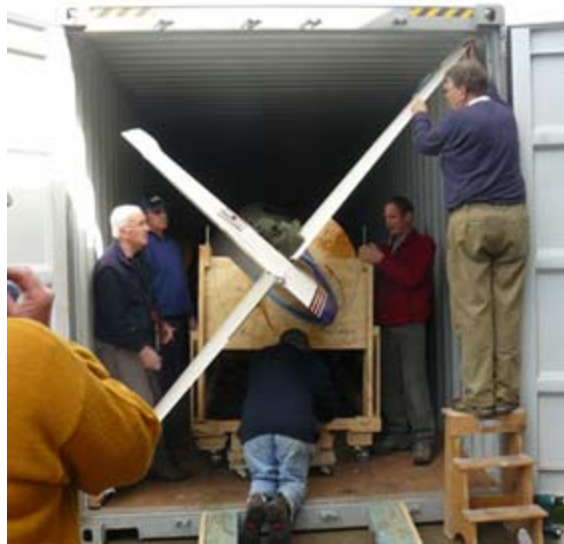
Transport required that the fuselage be rotated to an angle of about 48 degrees to permit the horizontal stabilizer to fit through the door of a 40 foot "high cube" container. This in turn required construction of a fuselage carrier/cart that would permit the fuselage to be rolled into the container, rotated 48 degrees, and the tail height to be carefully adjusted to allow passage through the container door with about 30-40 mm of total clearance. These requirements are illustrated in the photo below taken during unloading.

Fuselage in container with cart

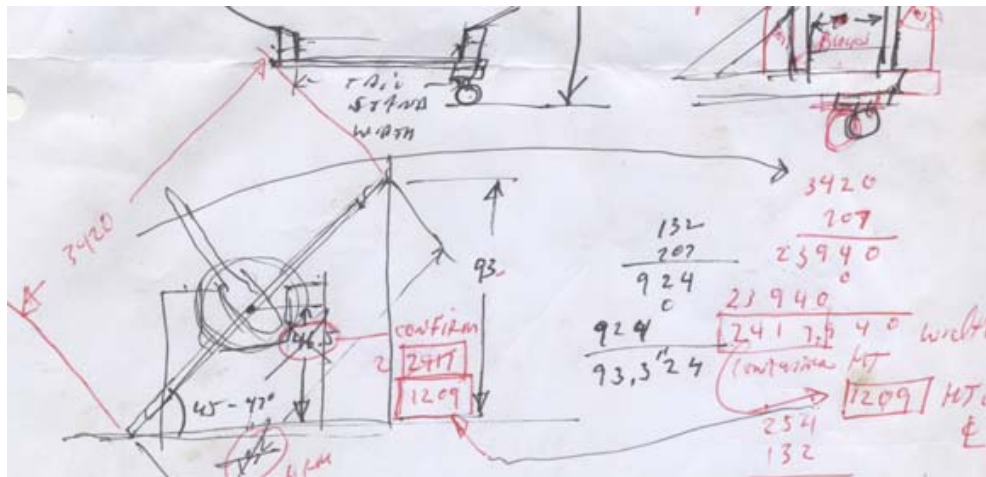
The fuselage cart had to be designed from memory and modified for reinforcement to reflect the shipping weight with engine attached and fuselage full. One of the drawings is shown below.

Find the error.....

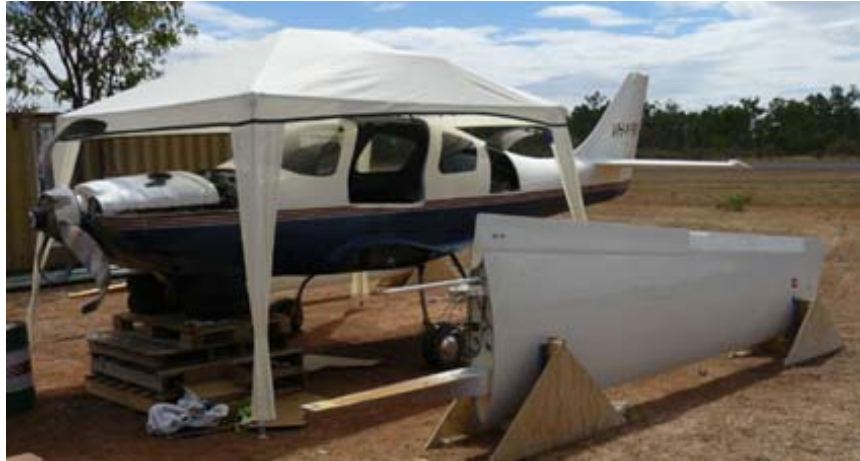
Wings in saddles

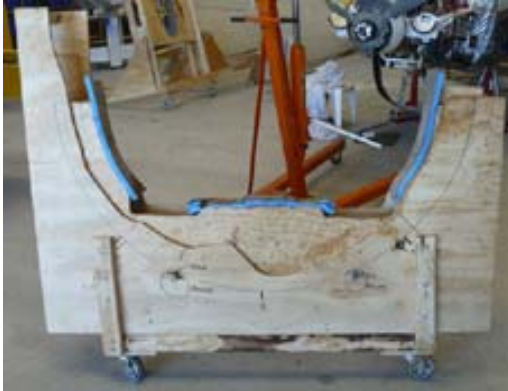
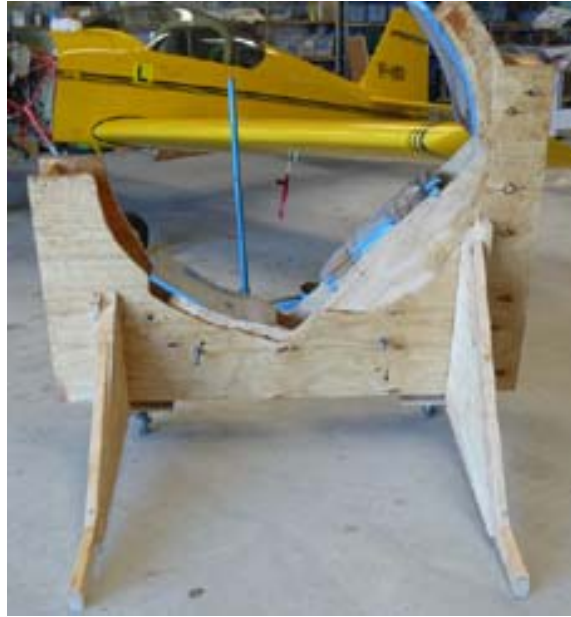
Front of fuselage stand, level and rear side rotated

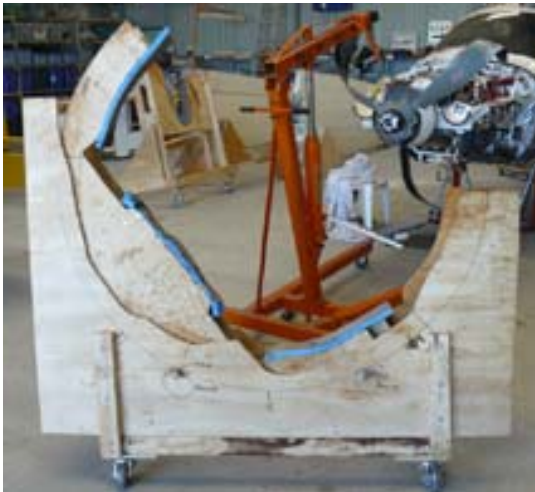
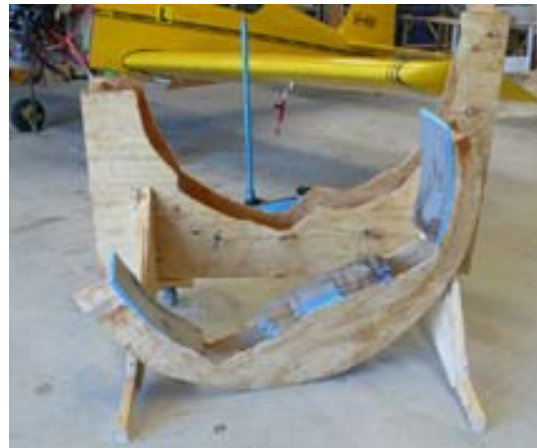
Fuselage stand front rotated and with rear side with rotator cradle removed

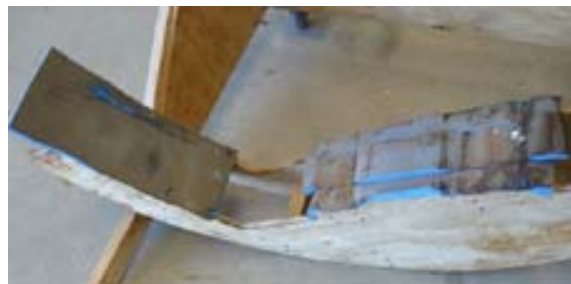
Foam padding on rotator cradle

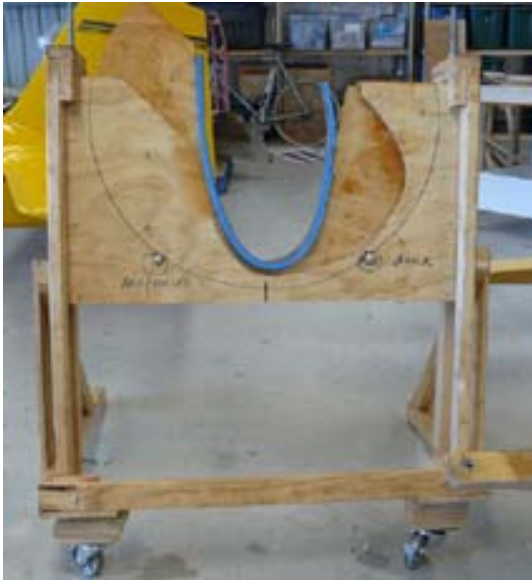
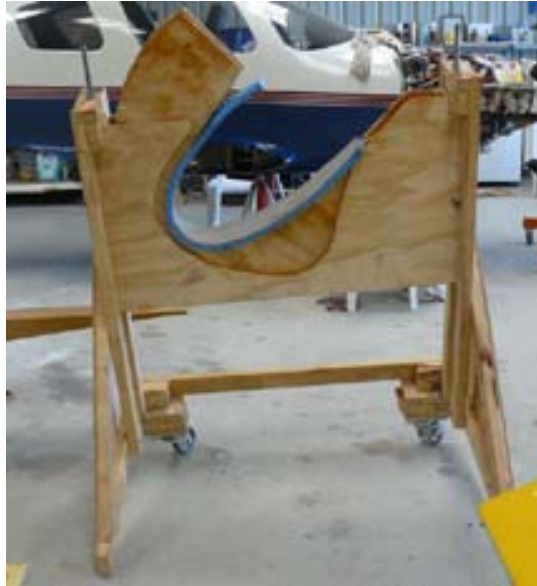
Fuselage tail stand with vertical adjustment, vertical and rotated positions

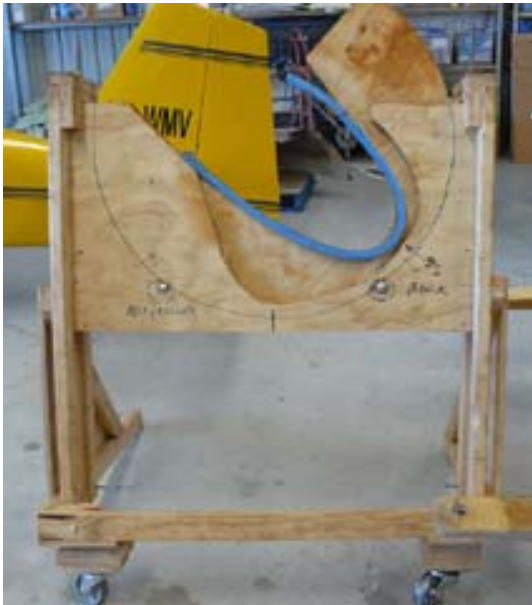
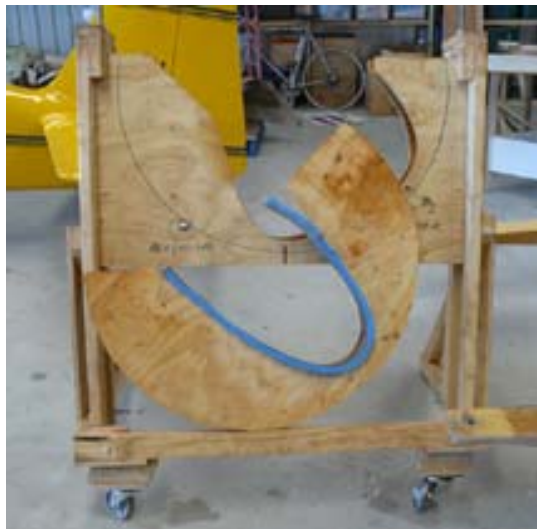
Back side of rear fuselage stand rotated, and rotator cradle removed
