VISUAL EXAMINATION OF A BROKEN ROCKER ARM

REPORT NUMBER: PHT/MET /08/10-2

August 2010

Report No: PHT/MET /08/10-2
Date: August 2010
Client: Fredrick Moreno
Item: Engine rocker arm
Application: Continental IO-550N, opposed 6 cylinder,
310 HP, light aircraft internal combustion engine.
Service Life: Total time on the rocker arm was 90 hours at failure

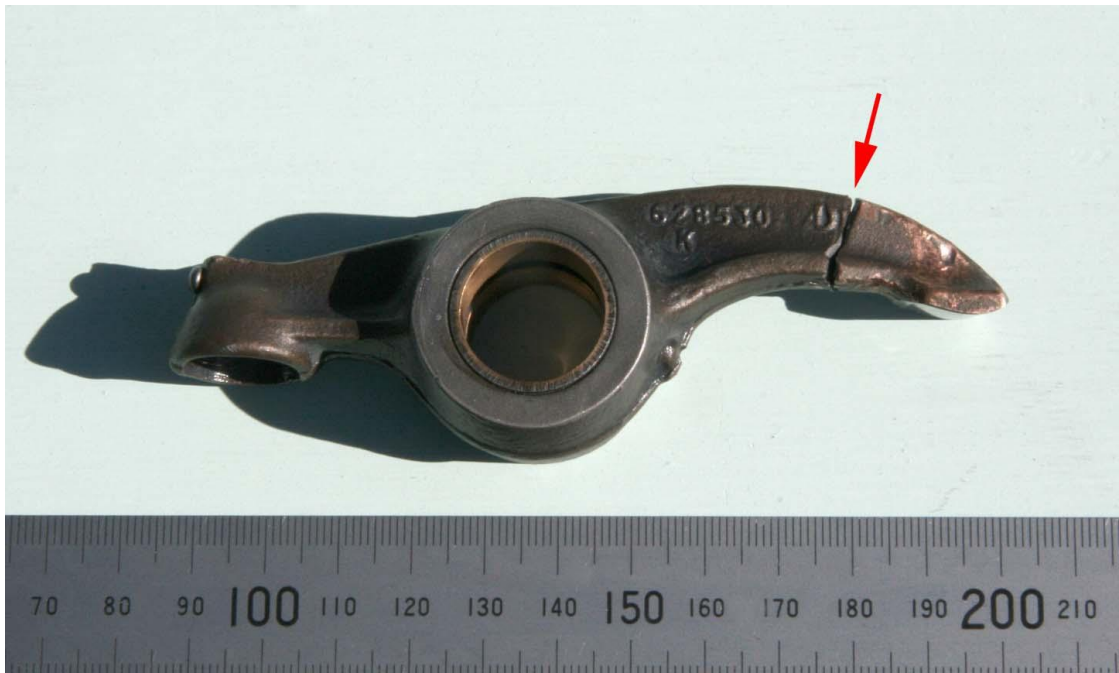
Figure 1 shows a general view of the broken rocker arm with the fracture position indicated by an arrow. The embossed casting identification was 628530 K ADI. The colour indicated that the rocker arm was electroplated with copper during manufacture.

Figure 1 General view of the broken rocker arm with the fracture position indicated by an arrow. The embossed casting identification is 628530 K ADI. The colour indicates that the rocker arm was electroplated with copper during manufacture.

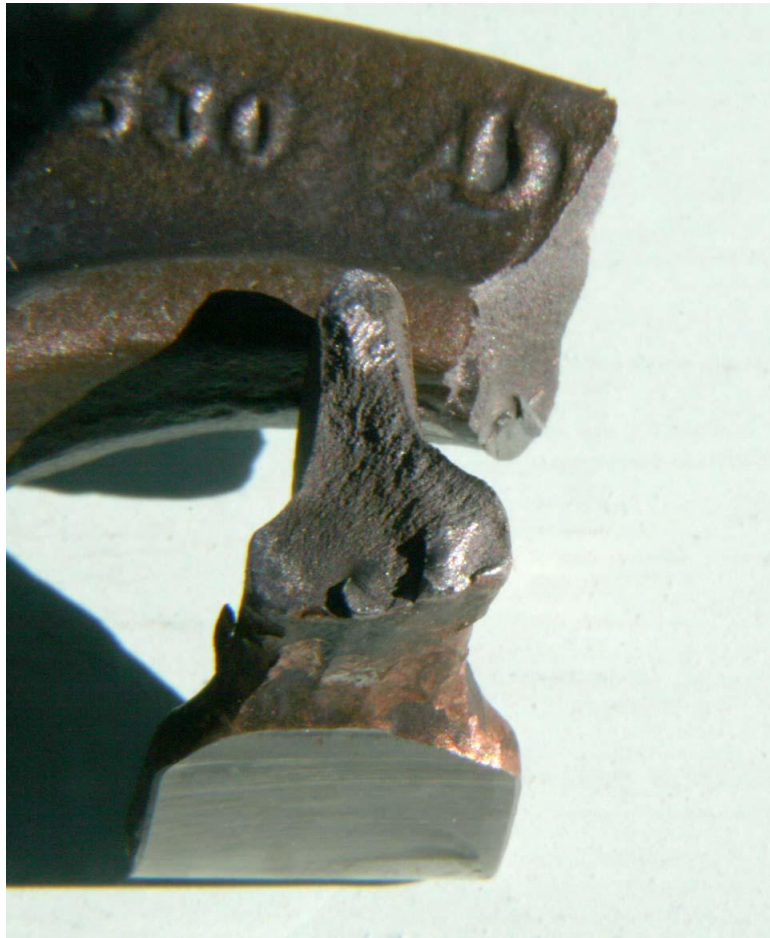
Figure 2 shows the fracture surfaces on the detached rocker tip and main arm. The curved rocker tip surface was bright and free from copper. Original grinding scores from manufacture were evident on the rocker tip.

Figure 2 Fracture surfaces on the detached rocker tip and main arm. The curved rocker tip surface is bright and free from copper. Original grinding scores from manufacture can be seen on the rocker tip

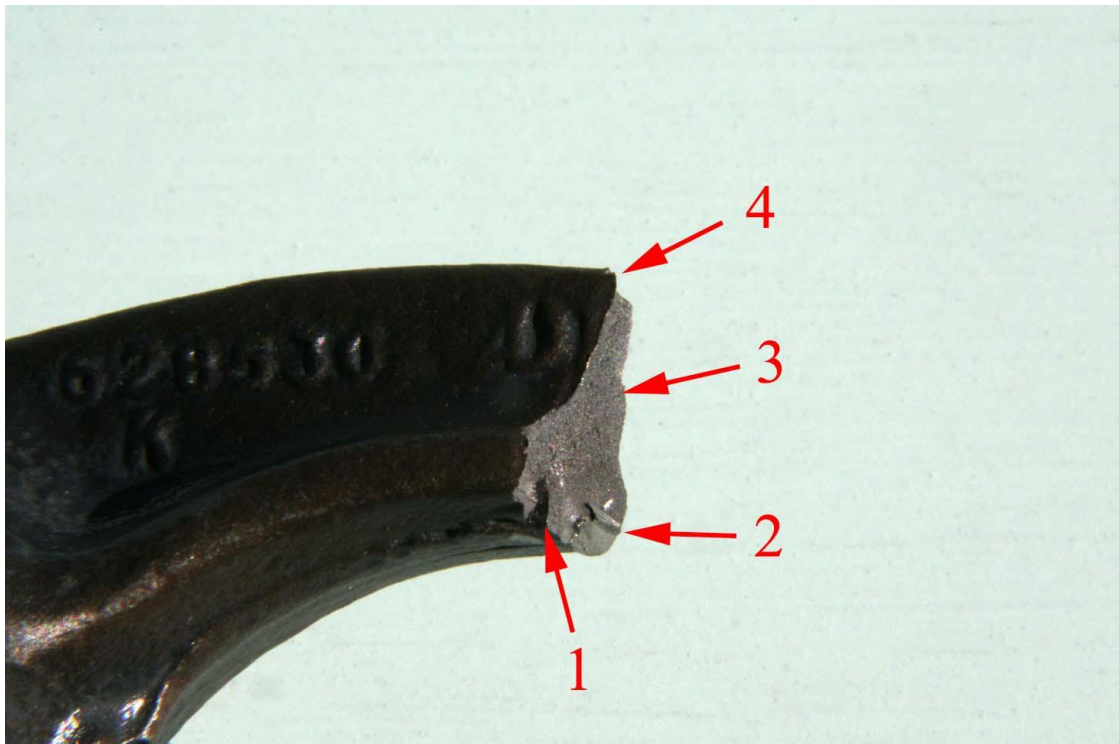
Figure 3 shows an oblique view of features evident on the main arm fracture surface. Arrow 1 indicates a dark area in an axial plane. Arrow 2 indicates smearing metal on the fracture surface. Arrow 3 indicates the main fracture surface. Arrow 4 indicates a shear lip.

Figure 3 Oblique view of features evident on the main arm fracture surface. Arrow 1 indicates a dark area in an axial plane. Arrow 2 indicates smearing metal on the fracture surface. Arrow 3 indicates the main fracture surface. Arrow 4 indicates a shear lip.

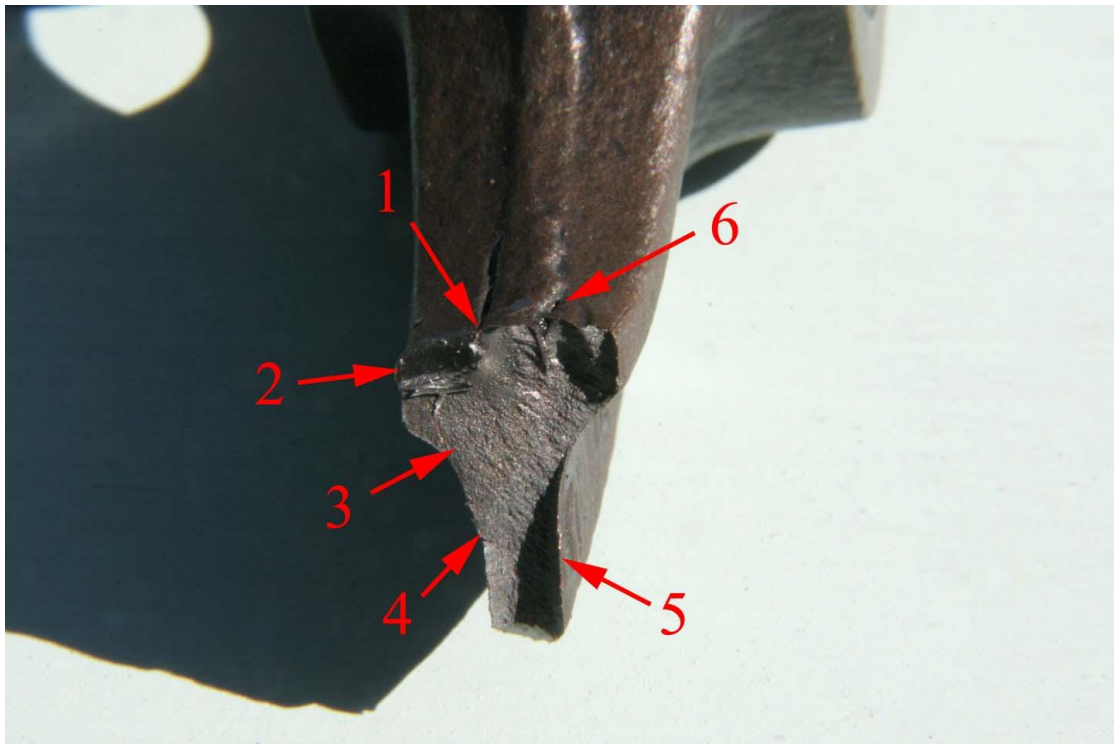
Figure 4 shows the main arm fracture surface viewed inverted and in the axial direction. Arrow 1 indicates an axial groove along one side of a mould joint line. Arrow 2 indicates the region of smeared metal. Arrow 3 indicates a lightly tarnished area containing fatigue crack growth striations. Arrow 4 indicates the transition between lightly tarnished and brighter fracture surface. Arrow 5 indicates the shear lip. Arrow 6 indicates another axial groove along the other side of the mould joint line.

Figure 4 Main arm fracture surface viewed inverted and in the axial direction. Arrow 1 indicates an axial groove along one side of a mould joint line. Arrow 2 indicates the region of smeared metal. Arrow 3 indicates a lightly tarnished area containing fatigue crack growth striations. Arrow 4 indicates the transition between lightly tarnished and brighter fracture surface. Arrow 5 indicates the shear lip. Arrow 6 indicates another axial groove along the other side of the mould joint line.

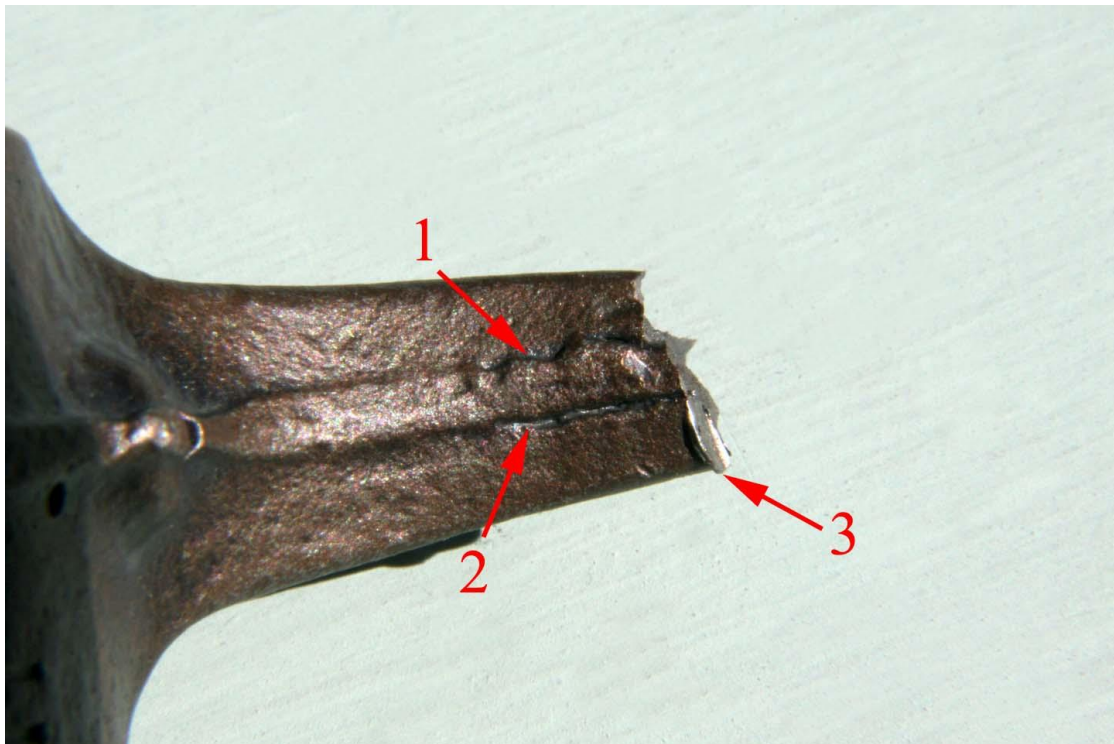
Figure 5 shows the underside or service tension side of the broken rocker arm. Arrow 1 and arrow 2 indicate the grooves to either side of the mould joint line. Arrow 3 indicates a flow lip associated with the area of smeared metal on the fracture surface.

Figure 5 Underside of the broken rocker arm. Arrow 1 and arrow 2 indicate the grooves to either side of the mould joint line. Arrow 3 indicates a flow lip associated with the area of smeared metal on the fracture surface.

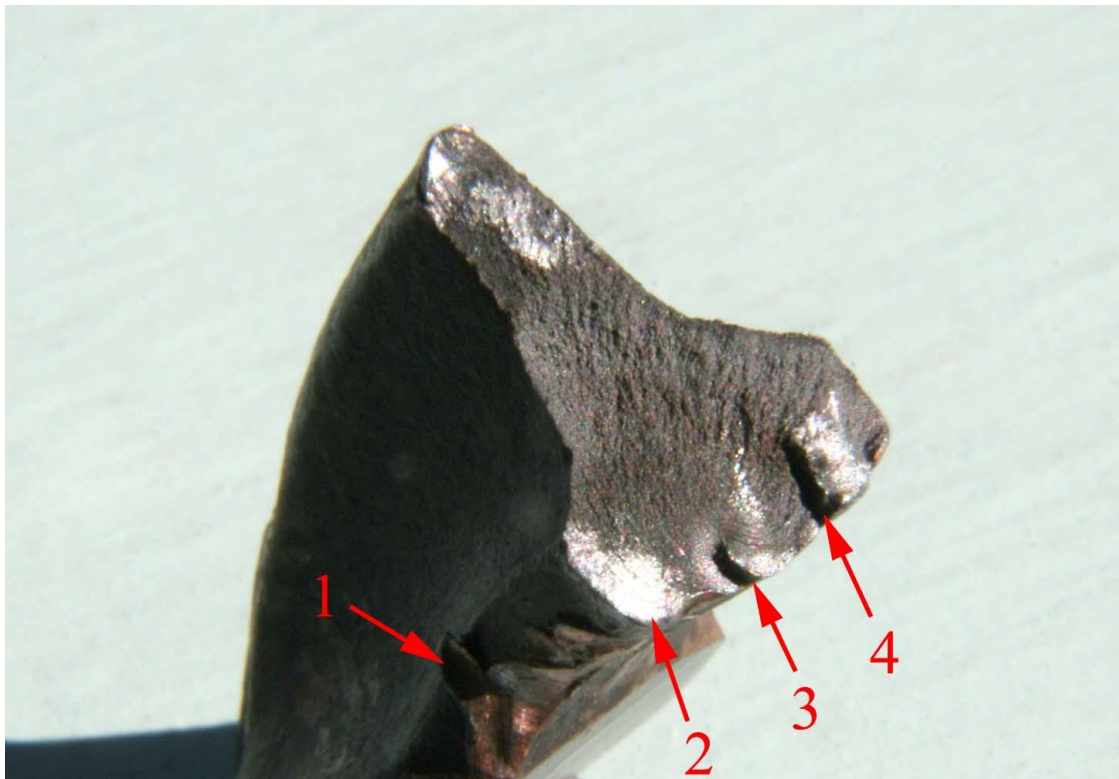
Figure 6 shows the fracture surface on the detached piece of rocker tip. Arrow 1 indicates a set of gouges. Arrow 2 indicates an area of polishing on the fracture surface. Arrow 3 and arrow 4 indicate surfaces which correspond to extensions of the two grooves shown in figure 5.

Figure 6 Fracture surface on the detached piece of rocker tip. Arrow 1 indicates a set of gouges. Arrow 2 indicates an area of polishing on the fracture surface. Arrow 3 and arrow 4 indicate surfaces which correspond to extensions of the two grooves shown in figure 5.

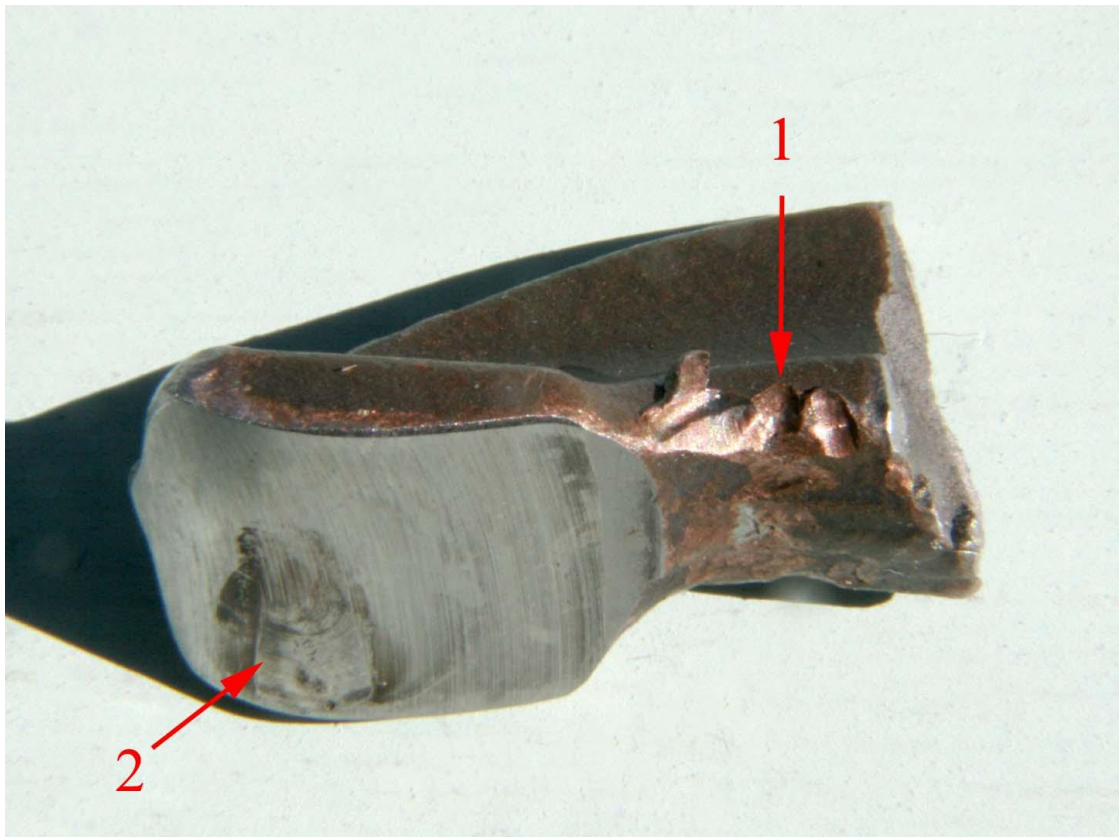
Figure 7 shows gouges (arrow 1) and wear on the rocker tip surface (arrow 2).

Figure 7 Gouges (arrow 1) and wear on the rocker tip surface (arrow 2).

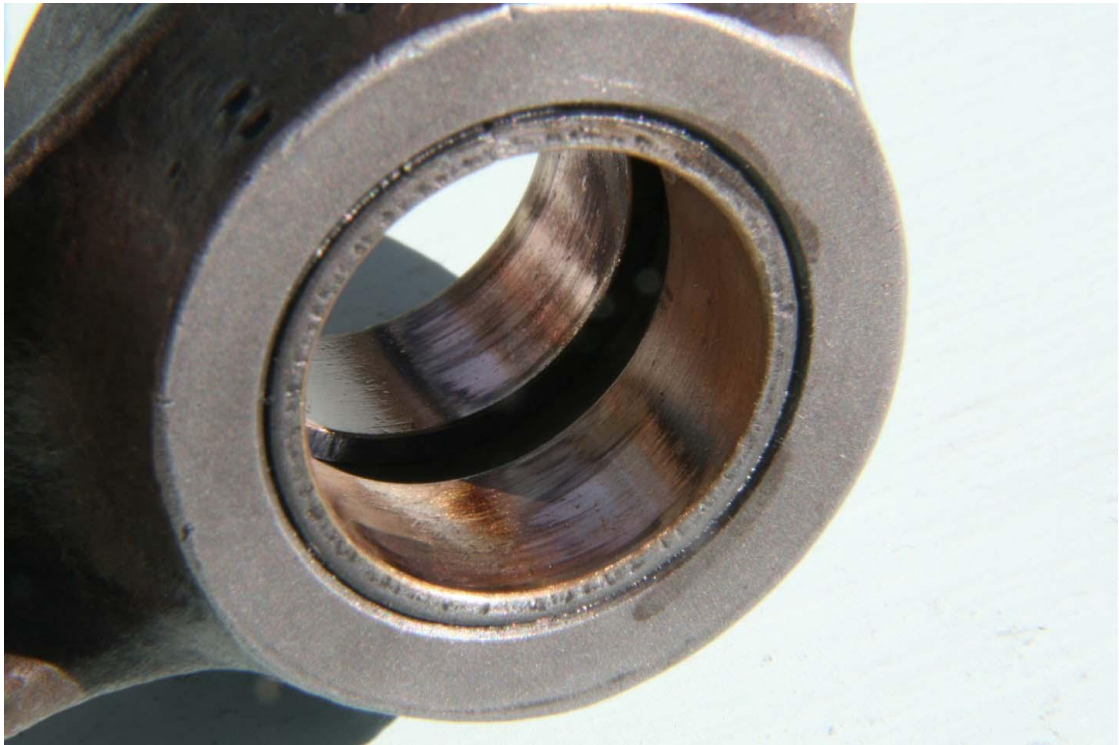
Figure 8 shows polishing wear of the bearing bushes.

Figure 8 Polishing wear of the bearing bushes.

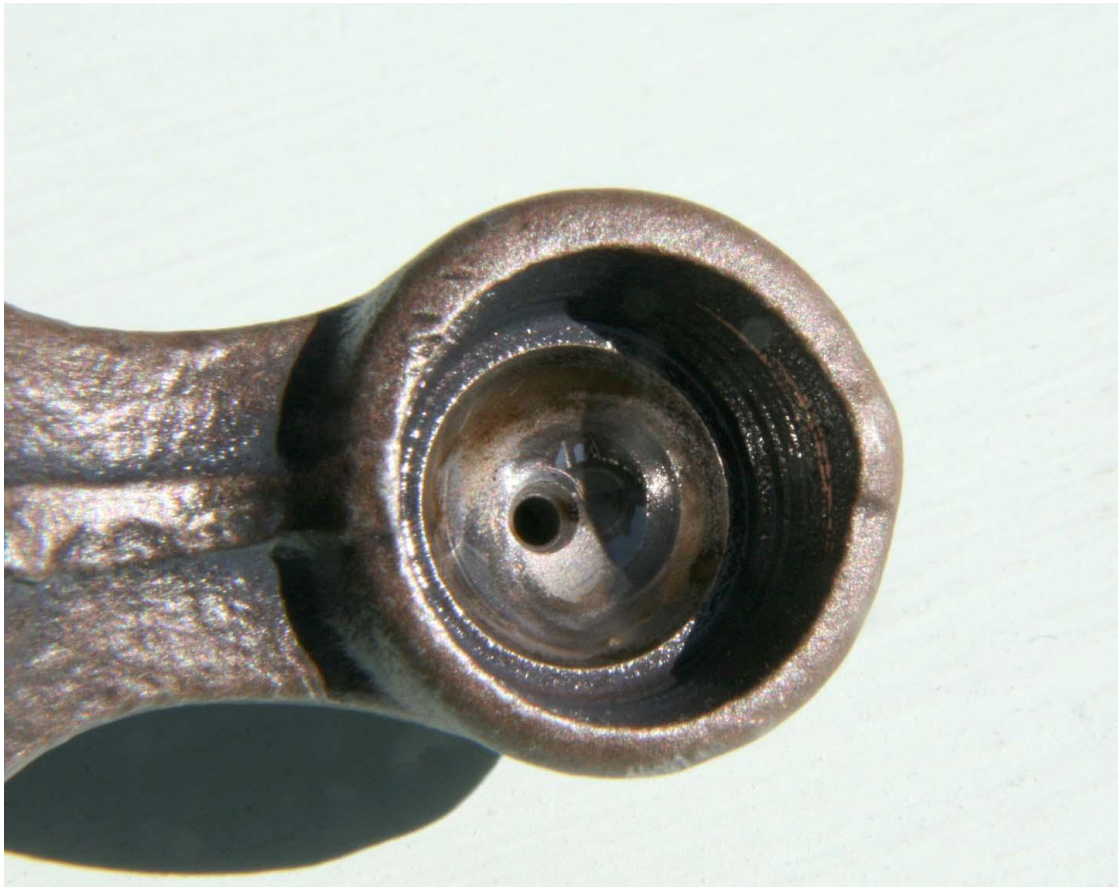
Figure 9 shows a close up view inside the push rod cup.

Figure 9 Close up view inside the push rod cup.

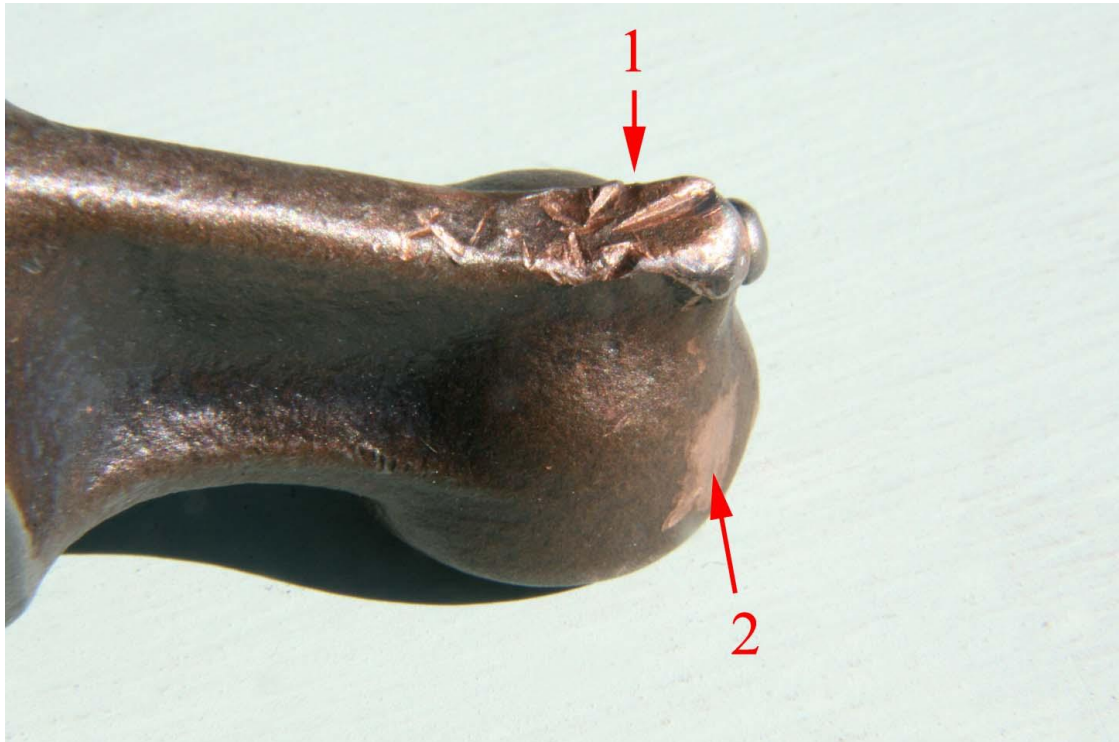
Figure 10 shows indentations (1) on the top surface of the push rod cup housing. Arrow 2 indicates an area of polishing wear on the outside surface of the cup housing.

Figure 10 Indentations (1) on the top surface of the push rod cup housing. Arrow 2 indicates an area of polishing wear on the outside surface of the cup housing.

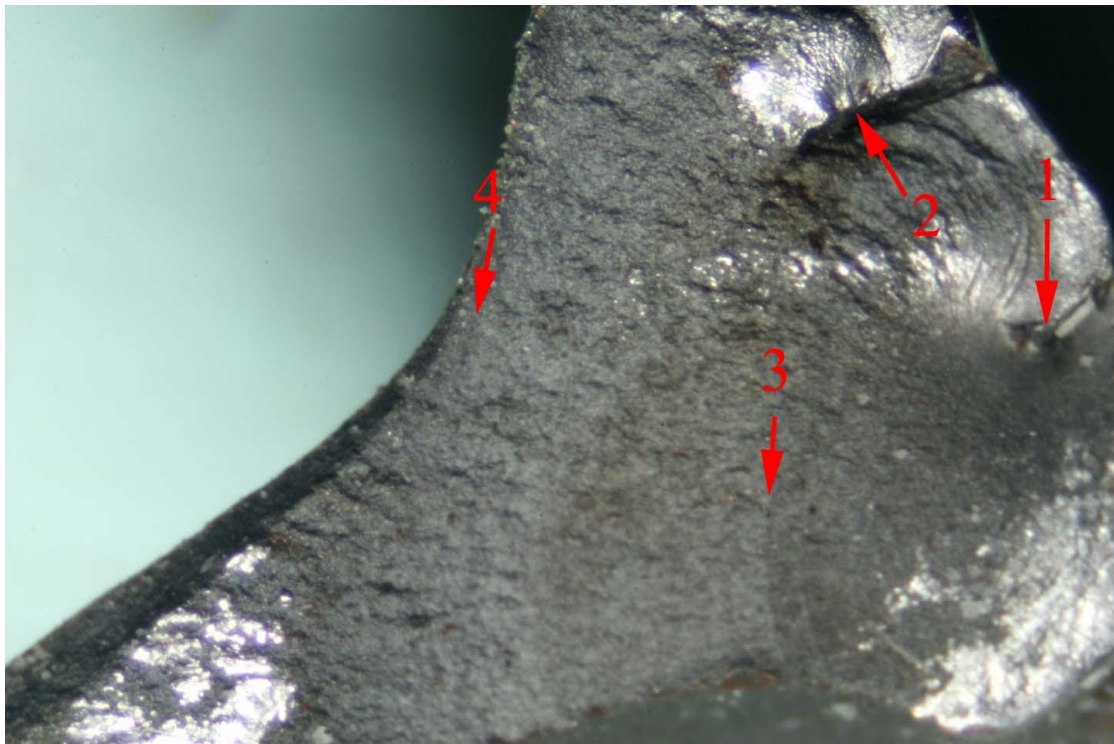
Figure 11 shows a magnified view of part of the fracture surface on the detached piece of rocker arm tip. Arrow 1 indicates an origin of fatigue at a seam in the casting. Arrow 2 indicates multiple origins of fatigue on a second

seam in the casting. This region appears to have been a secondary origin of fatigue. Arrow 3 indicates one of the more distinct fatigue crack arrest striations. Arrow 4 indicates fainter and more widely spaced fatigue crack arrest striations.

Two longitudinal seams or cold laps were accidentally formed during casting and these have acted as planar defects and initiation sites for fatigue crack growth in service.

Figure 11 Magnified view of part of the fracture surface on the detached piece of rocker arm tip. Arrow 1 indicates an origin of fatigue at a seam in the casting. Arrow 2 indicates multiple origins of fatigue on a second seam in the casting. This region appears to have been a secondary origin of fatigue. Arrow 3 indicates one of the more distinct fatigue crack arrest striations. Arrow 4 indicates fainter and more widely spaced fatigue crack arrest striations.

Testing of the rocker arms for similar manufacturing defects is relatively quick and easy provided that the arms are not already installed in an engine. Magnetic particle testing would readily reveal similar defects and the equipment is portable and can be used in any workshop with a 240 V AC outlet.

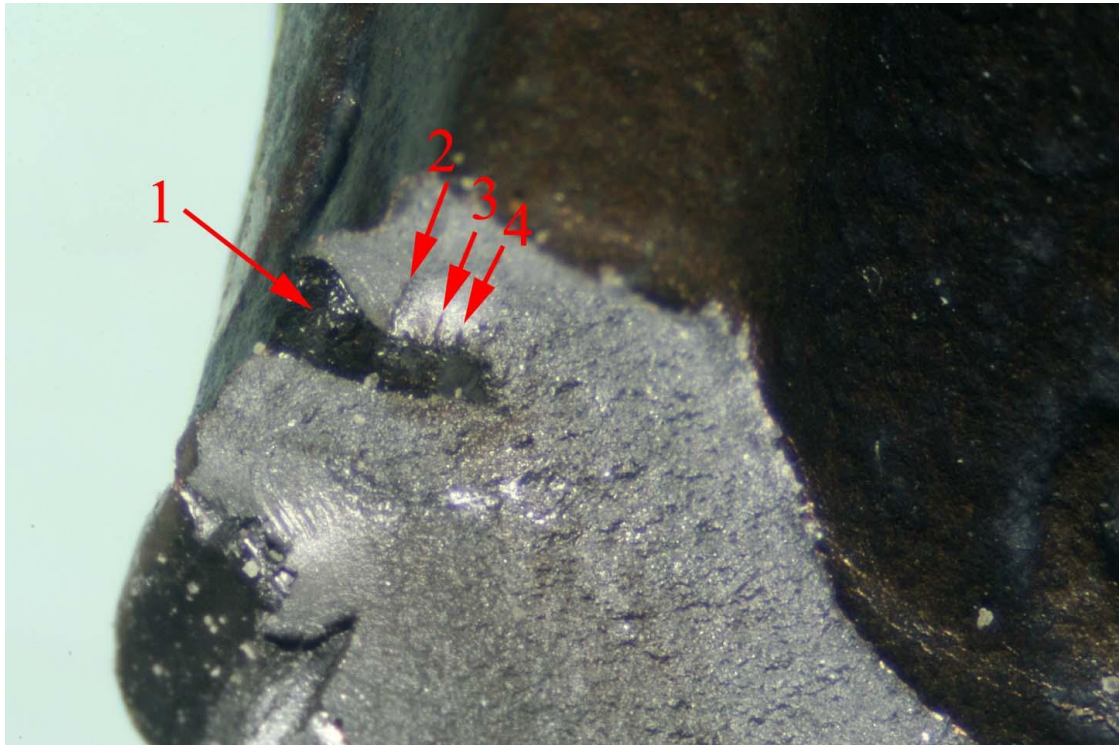
Figure 12 shows a magnified view of the multiple secondary origins of fatigue. Arrow 1 indicates a dark area of casting seam. Arrow 2, arrow 3 and arrow 4 indicate jogs which are a characteristic feature of multiple origin fatigue. The jogs are long thin triangular steps formed where fatigue cracks on slightly different planes approach each other and the ligament of metal breaks between the two fatigue cracks.

Figure 12 Magnified view of the multiple secondary origins of fatigue. Arrow 1 indicates a dark area of casting seam. Arrow 2, arrow 3 and arrow 4 indicate jogs which are a characteristic feature of multiple origin fatigue. The jogs are long thin triangular steps formed where fatigue cracks on slightly different planes approach each other and the ligament of metal breaks between the two fatigue cracks.
