# SPEEDBRAKES

SPDBRK

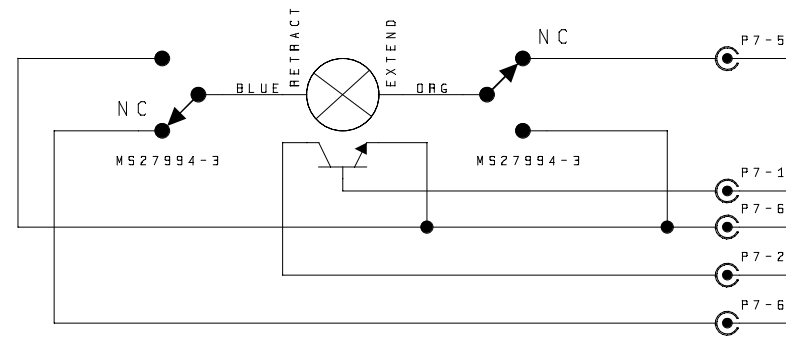
## LEFT BRAKE

EXTEND

COM  
RETRACT

2) AIRBRAKE MICRO SWITCHES SHOWN IN NC  
POSITION SO BRAKES ARE RETRACTING

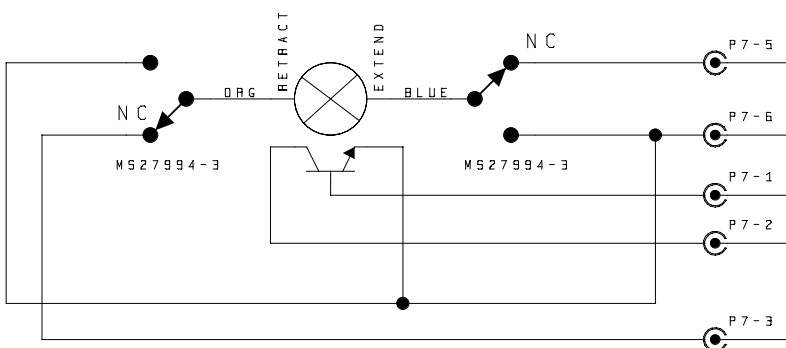
## RIGHT BRAKE

3) THE HALL EFFECT SENSORS ARE NOT USED

1) POSITIVE VOLTAGE ON AIRBRAKE RETRACT TERMINAL  
RETRACT
